**RESTORATION  
COMMENDED**

**Little Gaddesden  
Lodge  
Berkhampstead,  
Hertfordshire**

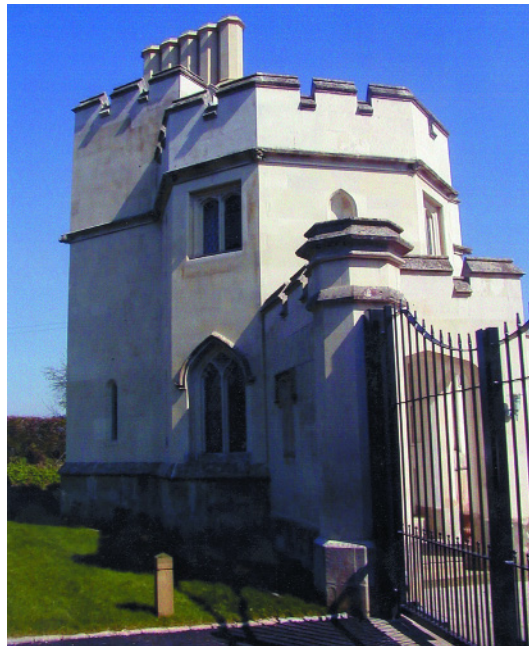
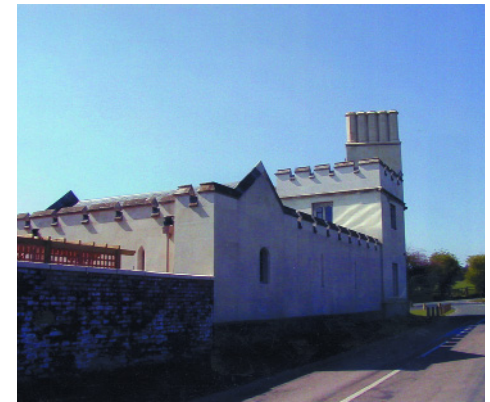
**This gatehouse to a large country manor was built of local clunch, which is not known for its weathering. Restoration contains a balance between piecing in of new stone and the usual spinning back of the face to sound surface. A solution which suits clunch.**

The string courses, parapets and coping stones had been replaced in Portland stone during an earlier restoration project and the remaining Totternhoe was badly perished.

There was rendering on some areas, which was cracking and falling off.

Rusted iron cramps had caused a significant part of the damage. They were replaced with stainless steel cramps.

All the ashlar to the building had to be replaced, using new Totternhoe stone treated on four sides with a mixture of linseed oil and turpentine when fixing.

The original course heights were maintained with 3mm joints. Half the window surrounds also needed

replacing.

Original chimney stacks were missing and archive photographs were used to design and construct new ones using Stoke Ground Bath Stone, which it was felt would be more durable than the clunch.
